## 102 Metal Repair Fluid

**102 Metal Repair Fluid** is a two component solvent free epoxy metal fairing compound. The product has been designed for use on a wide range of metallic surfaces and once cured is readily machinable.

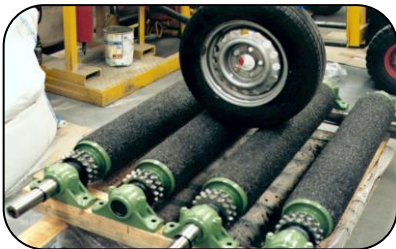
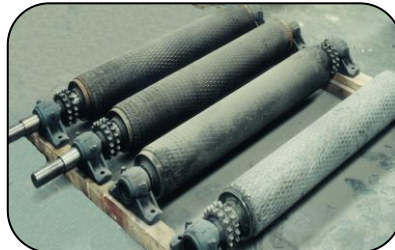
Resurfacing of brake test rollers using 102 Metal Repair Fluid

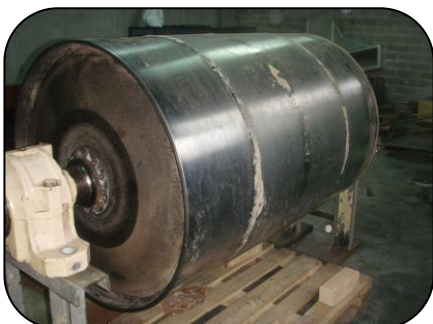
Belt rollers resurfaced using 102 Metal Repair Fluid and Aluminium Oxide
